[Docket No. 2002-SW-46-AD; Amendment 39-12910; AD 2002-21-04]

Airworthiness Directives; Agusta S.p.A. Model A119 Helicopters

2002-21-04 Agusta S.p.A.: Amendment 39-12910. Docket No. 2002-SW-46-AD. Supersedes Emergency AD 2002-17-52, Docket No. 2002-SW-43-AD and EAD 2002-14-51, Docket No. 2002-SW-35-AD.

Applicability: Model A119 helicopters with hub and tail rotor blades assembly, part number (P/N) 109-8131-02-149, or tail rotor blades, P/N 109-8132-01-111, installed, certificated in any category.

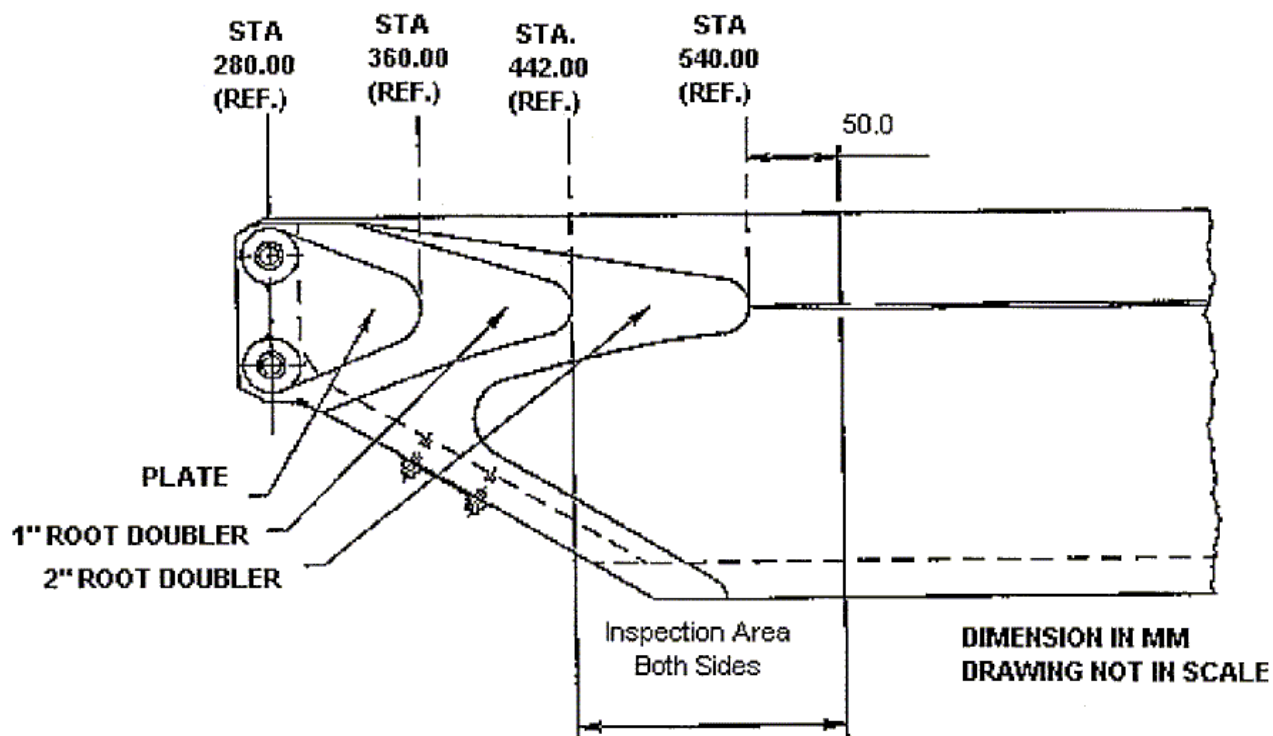
FIGURE 1

(b) Before each start of the helicopter engine, visually check both sides of each tail rotor blade for a crack in the area depicted in Figure 1 of this AD. An owner/operator (pilot) holding at least a private pilot certificate may perform this visual check and must enter compliance with this paragraph into the aircraft maintenance records in accordance with 14 CFR 43.11 and 91.417(a)(2)(v). See Figure 1:

Part Number 109-8132-01-111 Tail Rotor Blade

Note 2: Paint irregularities on the tail rotor blade may be due to a crack.

(c) Within 25 hours time-in-service (TIS), and thereafter at intervals not to exceed 25 hours TIS, and any time an increase in vibration levels occur, using a 5x or higher magnifying glass, visually inspect each tail rotor blade for a crack in accordance with the Compliance Instructions, Part III, paragraphs 1. through 5., of the BT. Reporting to Agusta Service Engineering is not required. If you are unable to determine by the visual inspection whether there is a crack, dye penetrant inspect the tail rotor blade for a crack in accordance with the Compliance Instructions, Part III, paragraph 6., of the BT.

(d) Replace any cracked tail rotor blade with an airworthy blade before further flight.
